Article

Impact of the September 2023 Storm Daniel and Subsequent Flooding in Thessaly (Greece) on the Natural and Built Environment and on Infectious Disease Emergence

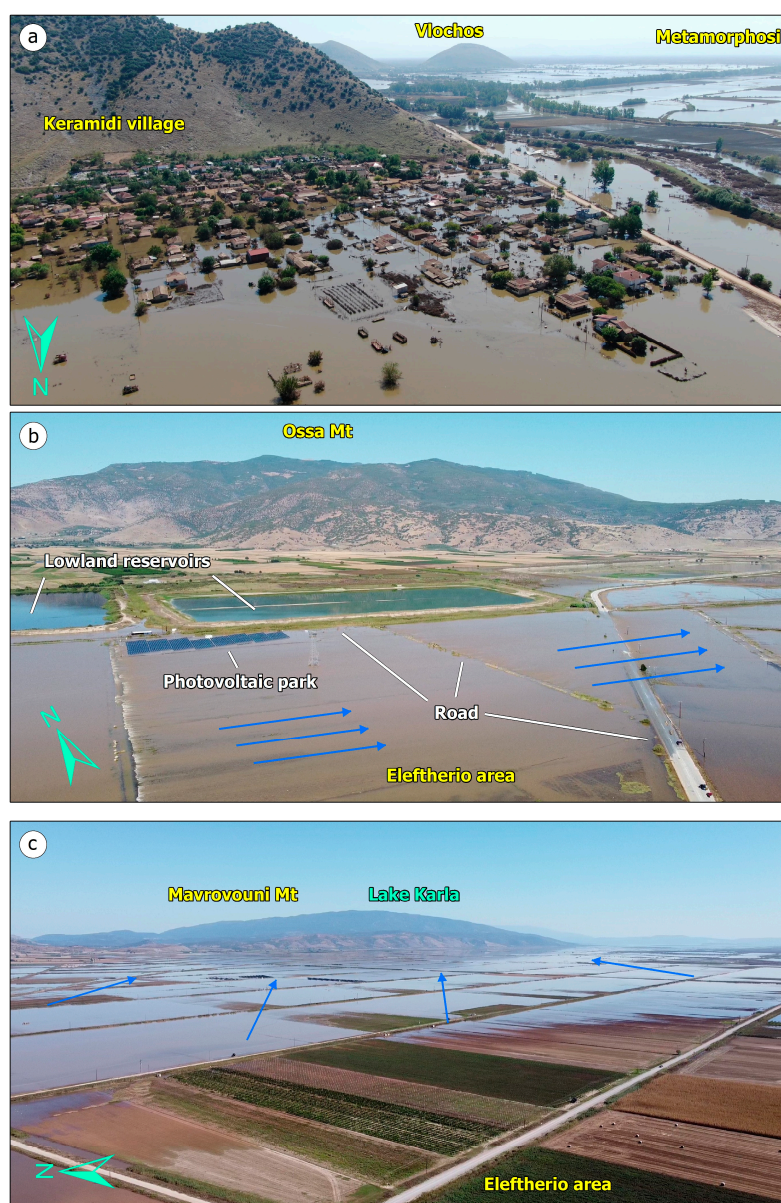
Figure 3. (a) Drone view from Keramidi village towards the south. The village is located within the Pineiada valley, formed between Antichassia and Titanos Mts, which are located north and south of Pineios River, respectively. This river valley connects Karditsa Plain with Larissa Plain. The village is located 27 km west of Trikala and 27 km east of Larissa. In the background, the flooded area of Vlochos,

Metamorfofi, and Palamas villages can be seen, which were severely affected by the flooding that followed storm Daniel. The houses remained below flood level for several days. (b) The area north of Eleftherio village, on the southwestern front of Ossa Mt, where flood water affected farmland, agricultural facilities, artificial lakes, a photovoltaic park, and a large part of the road network. (c) A view of the area east of Mavrovouni Mt, where flood water fed Lake Karla so that it regained its original size before 1962, when its drainage began. The blue arrows indicate the direction of floodwater flow towards Lake Karla (b,c).

The extreme values of precipitation in such a short time period resulted in the multiple failures of embankments in the main rivers and tributaries in the PCA, which caused extensive flooding (Figure 3) with floodwater reaching up to 4 m in many areas [7] (Figure 4). Many rural areas in the central and the northern part of the Thessalian Plain remained below flood water for several days [7]. The water continued its natural flow towards the Pineios River and ended up partly in Lake Karla and the Pineios estuary in the Aegean Sea (Figure 2), creating a new relief in the river delta [7].

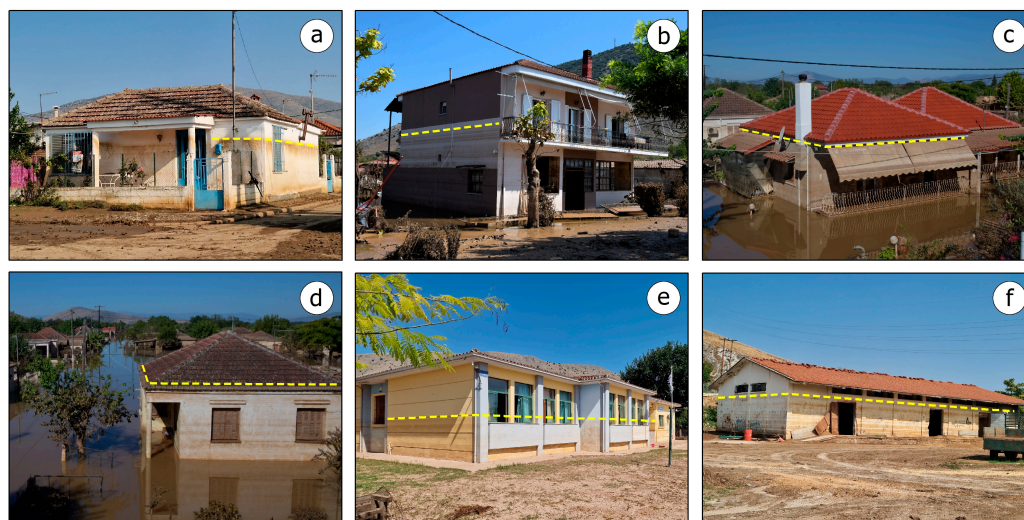
Figure 4. Typical views of structures in the flooded Thessalian Plain including (a–d) houses, (e) schools, and (f) warehouses. The level of the flood water has been imprinted on the walls and even on the roofs after receding and it is highlighted in the photos with a yellow dotted line. The flood water in many cases inundated not only the ground floor, but also the first floor of many houses, threatening residents and causing the total destruction of household equipment.

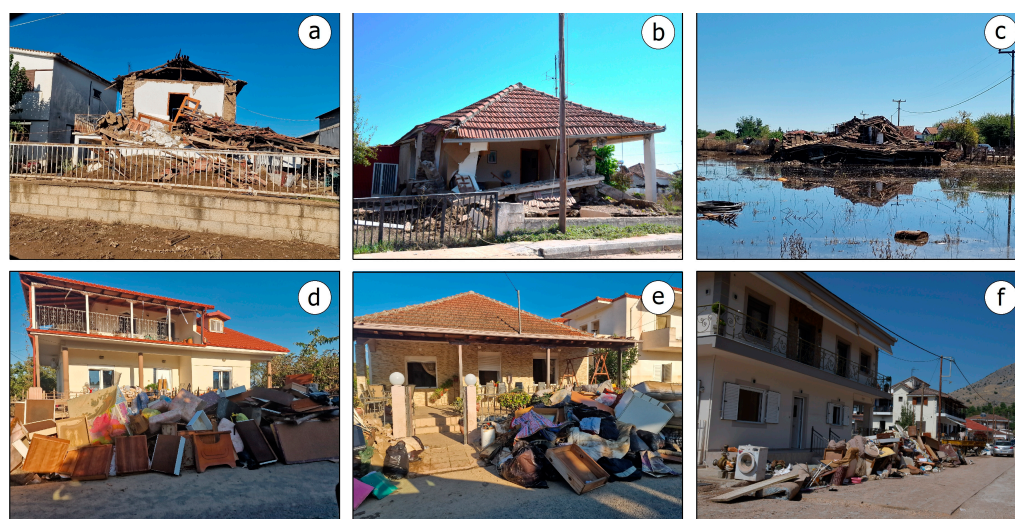
Figure 5. One of the main risks that emerged from flood water in the affected areas is related to flood waste management. Many masonry buildings suffered collapse (a–c), increasing the final flood waste volume. Many villages of the Thessalian Plain were inundated by flood water, resulting in the destruction of household equipment (d–f), buildings, and facilities. The resulting piles comprised hazardous materials with a high potential to affect not only the environment but also public health. Their collection, treatment, and disposal were a challenge for the authorities managing the disaster impact.

Flooding can affect buildings in urban and rural areas, resulting in considerable impact on their structural and non-structural elements and their equipment. Water flow can carry all of the above away and the flooding of areas for long periods of time can totally destroy them. These effects depend on the building construction type and the level that the flood water will eventually reach. With regard to the building construction type and the severity of the flooding effects on buildings in the Thessalian Plain, it was recorded that many of the buildings with load-bearing masonry walls were found covered by floodwater for many days. In many cases, the water reached either up to the roof of the ground floor or up to the middle of the first floor [7]. The result of these extreme hydrometeorological events was the partial or total collapse of many buildings with load-bearing masonry walls (Figure 5a–c). These collapses are mainly attributed to the presence of clay in the structural elements of the buildings and the lithology in the foundation and the surrounding area. The burden on these structures caused by recent destructive events in the area, such as the $M_w = 6.3$ and $M_w = 6.1$ Thessaly earthquakes generated on 3 and 4 March 2021, respectively, is also significant [15].

In the Thessalian Plain, not only agricultural land but also 21 villages were flooded. The flood water level either reached the roof of the ground floor or covered them completely. As a result, the household equipment of the houses and the professional equipment of the farms were completely destroyed. After the water receded, the residents who returned back home started repairing their premises. The owners emptied their houses of the destroyed equipment and the debris was placed on the street for the crews to pick up (Figure 5d–f). In many of the flooded villages, however, piles of flood debris were created [7], which even today, months after the water receded, have not been removed from the villages, posing safety and public health risks.

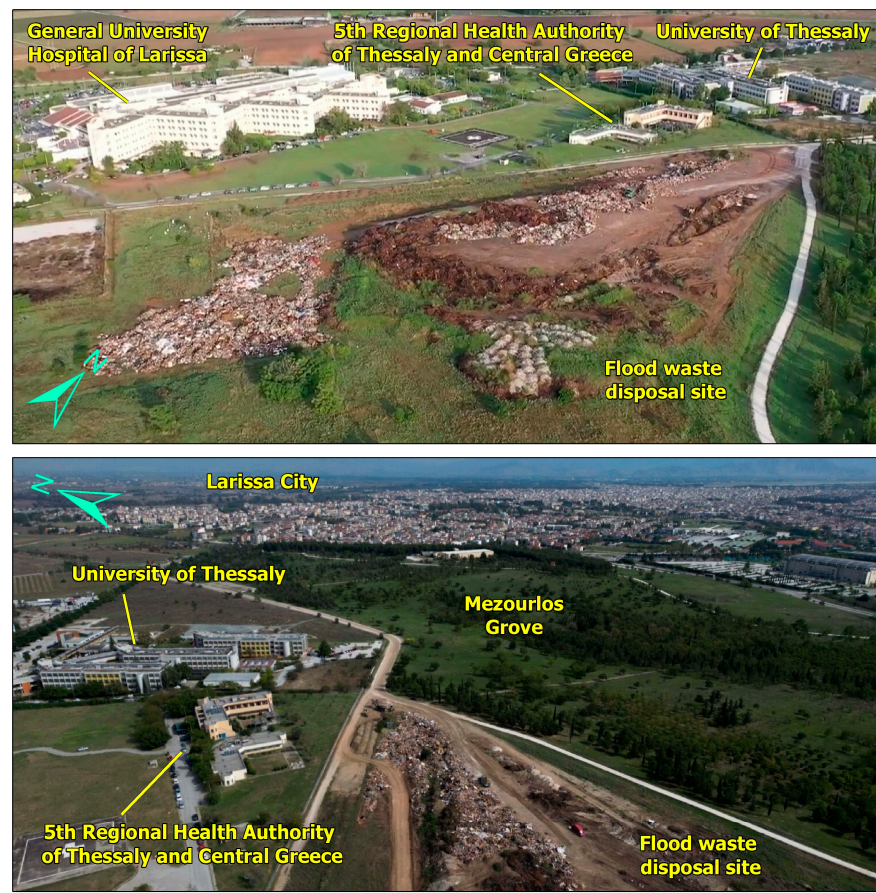
Figure 6. The flood waste disposal site created in the Mezourlos area located southwest of Larissa city. This site is characterized as unsuitable due to its proximity to critical health and education infrastructure and a suburban grove.

In terms of proximity to residential areas and critical infrastructure, the landfill of the Mezourlos area is the most typical example of a site on the outskirts of the city of Larissa (Figure 6). It was created in an area that was located close to (i) critical facilities, such as the General University Hospital of Larissa and the 5th Regional Health Authority of Thessaly and Central Greece; (ii) educational infrastructure, such as the University of Thessaly; and (iii) sensitive ecosystems, such as the Mezourlos Grove (Figure 6). In this site, flood waste such as furniture, household goods, and other bulky items from flooded houses and businesses were disposed of. The crushing of the waste was also reported, which further aggravated the situation not only at this site, but also in the surrounding area due to the dust clouds generated during processing and possible air pollution. Fortunately, further disposal was stopped at this site after the reopening of the Larissa landfill site, to which the flood waste from the Mezourlos site was also transferred. However, the same did not happen at all the aforementioned flood waste disposal sites.

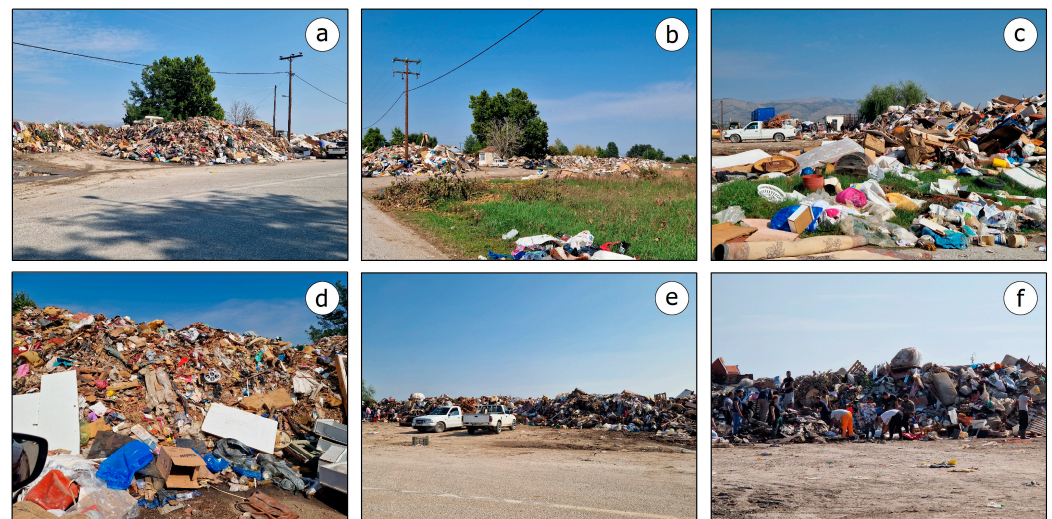
Figure 7. The large volume of flood waste in the Thessalian Plain was dumped uncontrollably in disposal sites (a,b) with easy access even by residents. The chaos observed in the flood waste piles (c,d) reveals that waste was disposed of without any prior sorting and treatment of harmful materials, posing threats to public health. Many residents coming from different cultural backgrounds and with limited family incomes searched the sites for items (e,f) that could be repaired, reused, and recycled, unaware of the public health risks arising from this activity.

In addition, the disposal sites close to the affected settlements were operated next to the road (Figure 7a,b) in large piles with various types of flood waste without sorting (Figure 7c,d). This enabled the immediate and easy disposal of waste even by residents. As a result, these disposal sites were able to receive waste even 5 months after flooding had occurred without any restriction from the competent authorities or prior sorting of the waste. This proximity enabled many residents, coming from different cultural backgrounds and with limited family income, to search the sites for objects that could be repaired, reused, and recycled (Figure 7e,f), unaware of the risks that this activity poses first to their health and then to public health.
